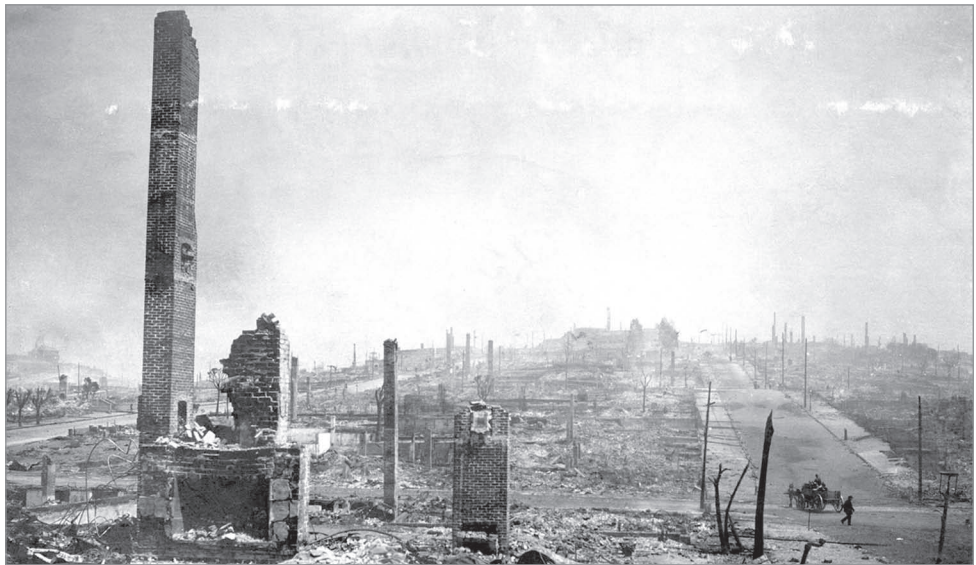
Images taken from Knob Hill after the earthquake in San Francisco, California on April 18, 1906. This view is from the corner of Van Ness Street and Washington Street. (Photograph credit: W. C. Mendenhall and US Geological Survey.)

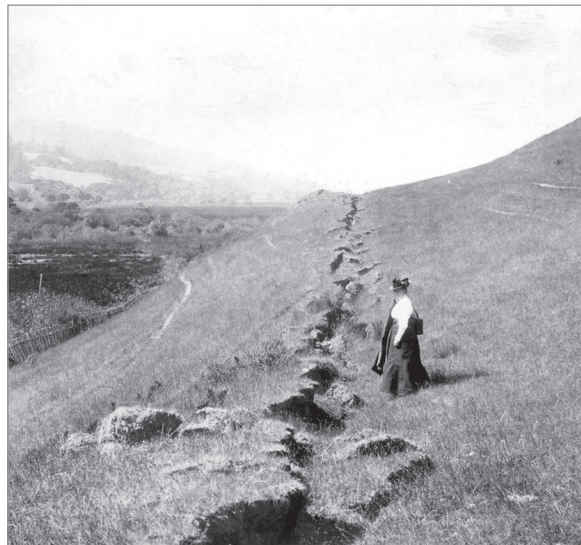
Right: Fault trace 2 miles north of the Skinner Ranch at Olema, looking north. (Plate 10, US Geological Survey Folio 193; Plate 3-A, US Geological Survey Bulletin 324. G. K. Gilbert, 1933.)

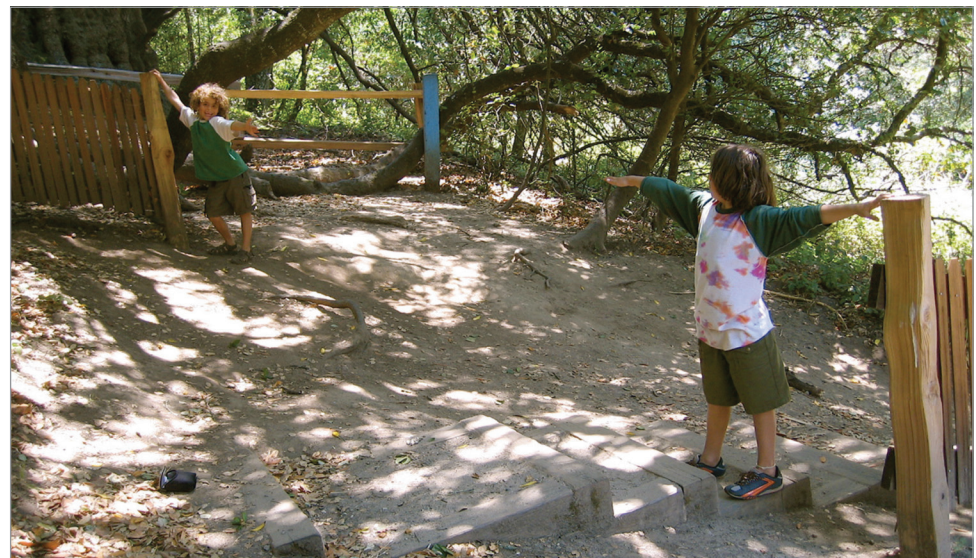
Modern reconstruction of the 1906 fence on the same site and in the same position. Note the displacement of approximately 7.6 m (25 ft) by 2006. (Photograph courtesy Tammi Grant.)
